# Manhole Inspection Summary

Manhole # S15EE1003MH

Record Plat: **15EE1** Node: **003** Status: **Found**

**Location** Address: **ALLEY BETWEEN COTTAGE &** Cross Street: **PALL MALL**

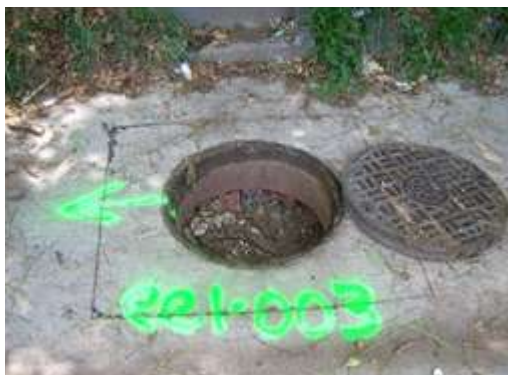
Location View

**Cannot Access - Terminal Manhole Filled With Concrete to Rim**

Comments **MANHOLE IS ABANDONED IT WAS FILLED WITH CONCRETE TOOK PICTURES OF AREA AND TOPVIEW**
